## Endodontic Mishaps in Mandibular 1<sup>st</sup> Molar: A Case Report

Dr. Pradnya V. Bansode, Dr. Seema D. Pathak, Dr. M. B. Wavdhane, Dr. Apurva Satpute

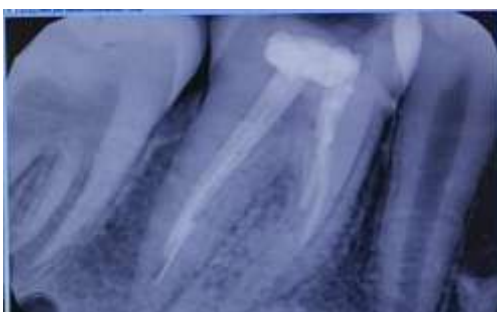
(Figure 1)

A 13years old male patient was referred to the Department of Conservative Dentistry and Endodontics with chief complaint of pain and swelling in the right lower back region of jaw since 3 months. Radiographic examination revealed under obturated canals with 46 , instrument separation in distobuccal canal at the junction of middle and apical third of canal and ledge formation in mesiobuccal and mesiolingual canals ( figure 1 ). It was diagnosed that 46 had symptomatic apical periodontitis so Re Root canal treatment was planned for 46.

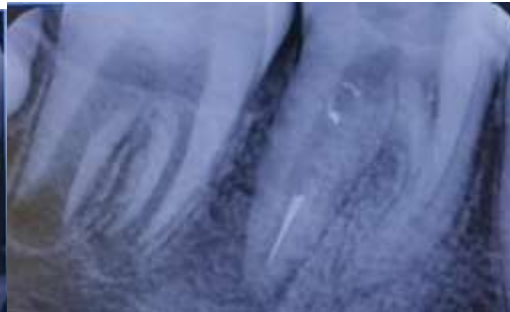
(Figure 2)

instrument separation in distobuccal canal at the junction of middle and apical third of canal and ledge formation in mesiobuccal and mesiolingual canal ( figure 2 ).. Initially ledge was bypassed slowly with no. 8 k file in both mesial canals under copious irrigation with 5.25% sodium hypochlorite solution. Remaining canals were blocked with cotton pellet to prevent entry of fractured instrument in other canals. Ultrasonic was activated at lower point setting with reduced water supply to enhance visibility into canal and vibrated in counter clockwise direction in order to loosen the instrument. With this trephining action vibrations being transmitted to the fractured instrument and it loosened and floated out of the root canal. ( figure 3,4 ). Woking length was determined with radiograph and confirmed with apex locator ( figure 5 ).. Cleaning and shaping was done. Thorough irrigation was done. The canals were dried with paper points and intra canal dressing of calcium hydroxide was given for 7 days and the tooth was temporized. After seven days, access cavity was re-entered and the canals were irrigated thoroughly with normal saline. Master cone selection for both the canals were done ( figure 6 ) and canals were obturated with cold, lateral compaction of gutta percha cones with epoxy resin sealer ( figure 7 ). A post obturation radiograph with composite resin restoration was taken to evaluate the quality of obturation ( figure 8 ).
