Successful Retrieval of Metal Post Using Ultra Sonics and Nonsurgical Retreatment of Maxillary Lateral Incisor Using Minimum Armamentarium: A Case Report

Vinayak Jyothi, Pradeep Kumar, Prathap M.S, Vivian D'costa,
Yenepoya Dental College, Mangalore, Karnataka

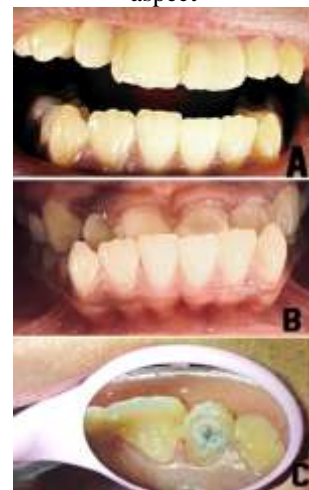
Tooth of concern was 12. On detailed examination it was noticed that the crown portion of 12 was mobile and the metal post was exposed in the palatal aspect. Patient had class III skeletal Malocclusion according to angles classification. Patient was asymptomatic. Tender on percussion was negative. No vestibular tenderness.

(Figure -1) A- Intra oral view, B) class III malocclusion, C) metal post seen in the palatal aspect

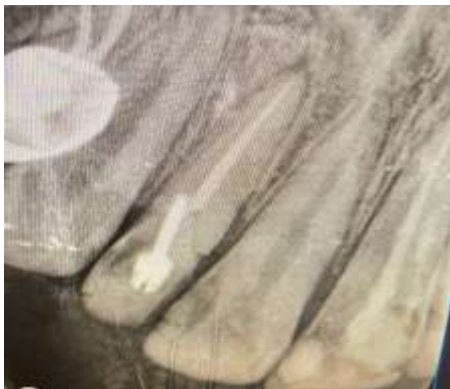
Radiographic examination reveals, tooth number 12 was root canal treated and rehabilitated using metal post and core. X-ray reveals Post space preparation was not sufficient enough to retain the post and the post was not placed in the right angulations, it is misplaced laterally towards the distal side. There were no significant peri apical changes. The tissue seems to be healthy.

Figure -2) Pre operative x-ray with respect to tooth no.12

Diagnosis – Fractured coronal restoration secondary to maligned post.

After thorough clinical and radiographic examination, treatment was planned and decision was taken for post retrieval and nonsurgical retreatment. Procedure was explained to the patient with possible risks including the fracture of tooth during post removal, before commencing the treatment and informed consent was obtained.

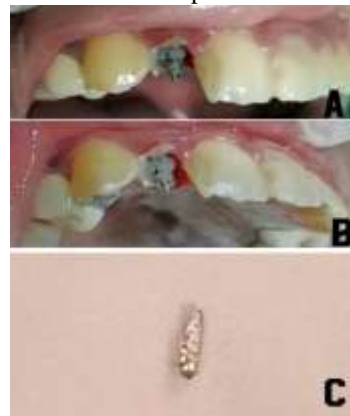
Treatment was initiated with removal of fractured coronal fragment and Access cavity preparation. Space was created by removing the restorative material in and around the post using number 2 round bur. On clinical examination, it was found that the post was not placed in a right angulation. Tapered diamonds were used to refine in gentle brushing movement and also to remove roughness, giving flaring along the walls axially to accomplish the modification in access cavity shape to gain adequate space around the post for easy removal. Restricted space between the post and the axial was instrumented using ultrasonic tips (ED 4D, ED5: DTE D5, Dr Talal Woodpecker Medical Instrument Co., LTD), which are meant to be used for these purposes. Principally, ultrasonic instrument which is parallel was made use of below the orifice level and lateral to the radicular post in an irregularly cleaned and shaped canal with clear field of vision. Attempt was made to unscrew the post, which was done using the artery forceps. May be due to the mechanical interlocking, restorative material, and incorrect angulation of the post, the

post fractured and a fragment of the post retained within the dentin. Through constant usage of ultrasonics and usage of artery forceps in anticlockwise rotation and gentle pull motion, the metal post was retrieved completely from the canal. Confirmatory radiographs were taken to analyse the radicular portion of the tooth.

Figure 3- A) After removal of fractured coronal segment, B) Retained post fragment, C) Retrieved metal post

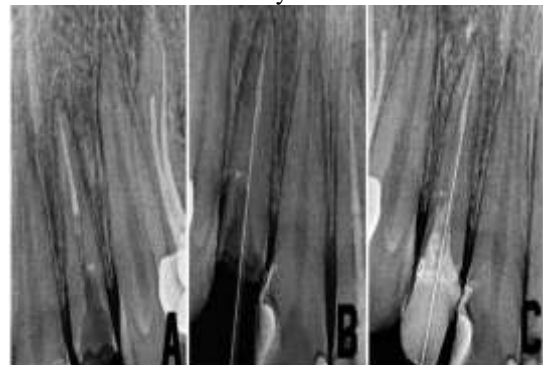
Once the post was retrieved the access to the canal was negotiated and GP removal was done using peeso reamer (Mani). Post space was prepared and confirmatory radiographs were taken. Working field was isolated by placing polytetrafluoroethylene tape on the adjacent teeth. The crown build up was done using a glass fibre serrated no-2 post (Angelus Reforpost Fibre Glass) and core was build using dual cure resin cement (Coltene Paracore kit). Gross finishing and polishing of the crown was done in the first appointment.

Figure 4- A) Post space preparation x-ray, B) Fibre post placement confirmatory x-ray, C) fibre post and core cementation x-ray

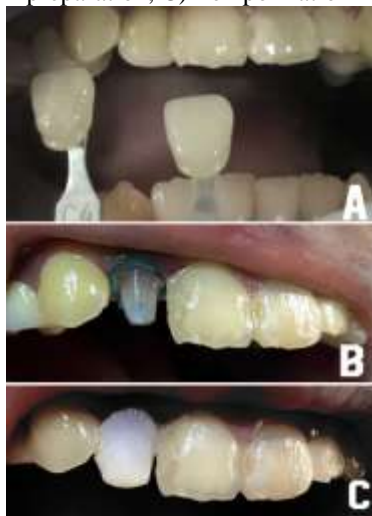
In the second appointment, shade selection was done. Crown preparation was done using tf13 bur (prima crown preparation kit). Due to lack of coronal structure the finish line was placed on the root surface of the coronal root. Gingival retraction cord no 0 was placed (Pascal Knit-Trax) to retract the gingiva prior to the impression making. The prepared tooth surface was temporized using cool temp material (coltene).

Figure 5- A) Shade selection, B) Crown preparation, C) Temporization

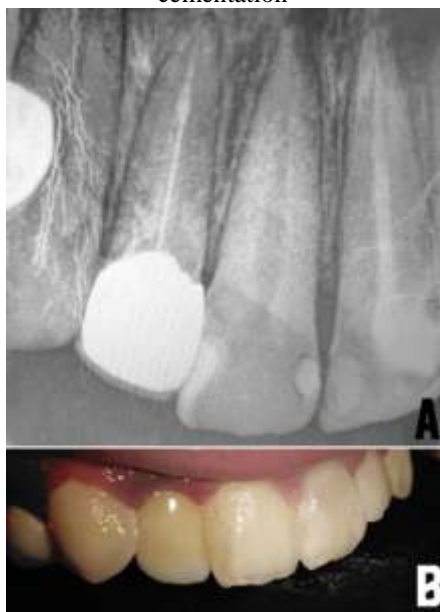
In the 3rd appointment, tooth number 12 was rehabilitated by a Zirconia full coverage restoration.

Figure 6- A) Post operative radiograph, B) Post cementation
